**SHAKER MEETING HOUSE – ALBANY, NY
MECHANICAL & ELECTRICAL SYSTEMS ASSESSMENT**

LANDMARK FACILITIES GROUP, INC.

December 2020

ASSESSMENT OF MECHANICAL, ELECTRICAL AND PLUMBING SYSTEMS

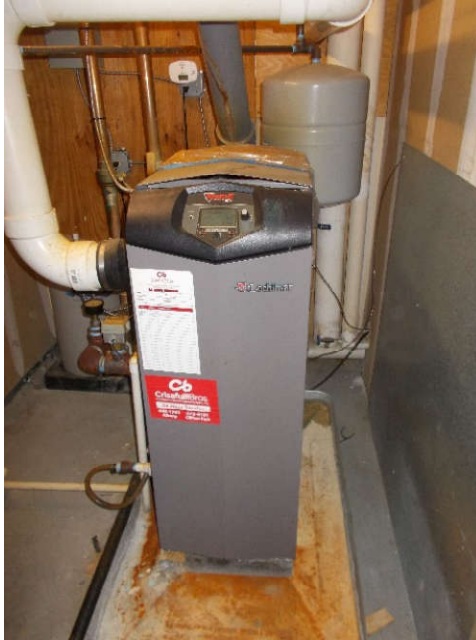
Gas-fired condensing boiler on 3rd floor

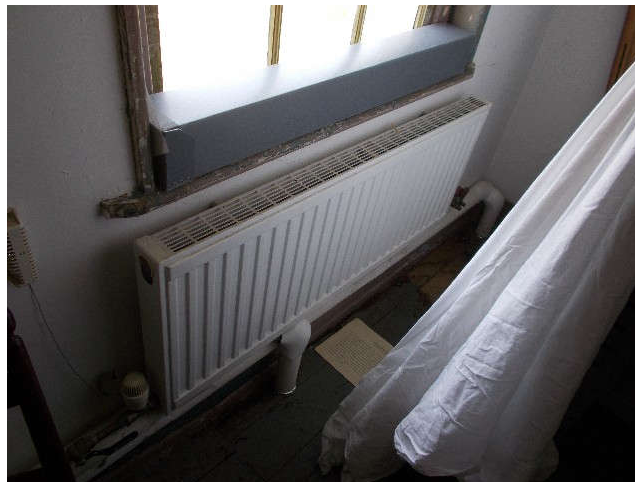
Typical steel hot water radiator with thermostatic valve (at left)

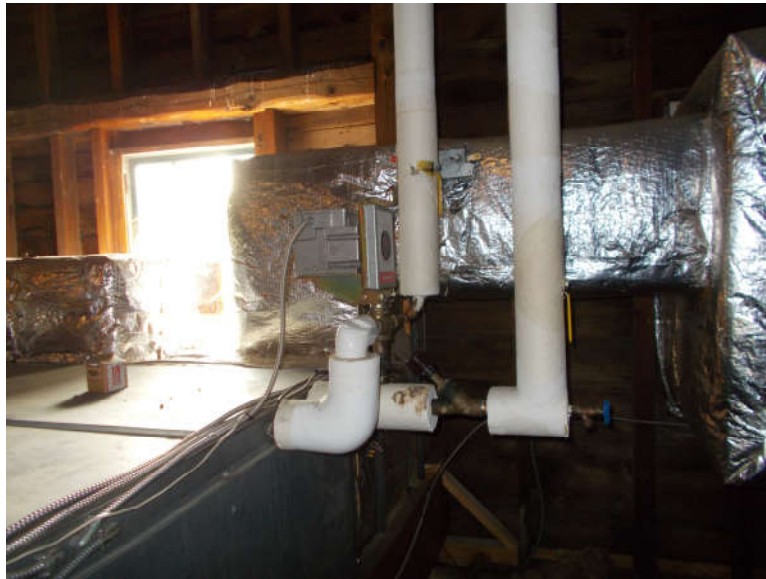
Hot water piping and motorized control valve at air handler

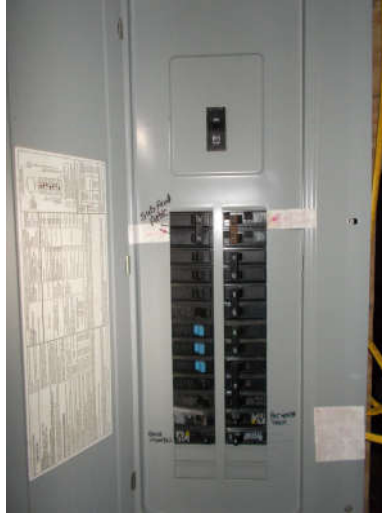
Photo 1 - Panel in basement

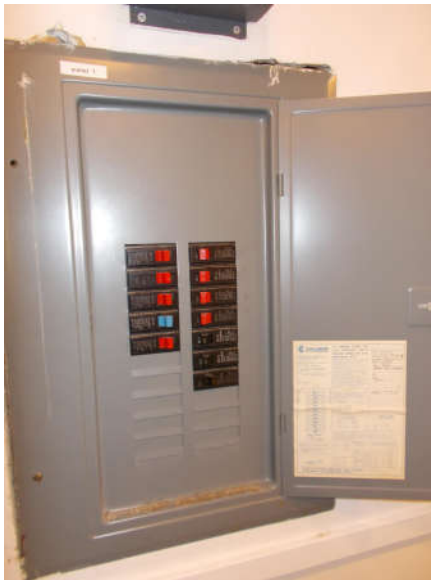
hoto 1 - Panel 1 on first floor

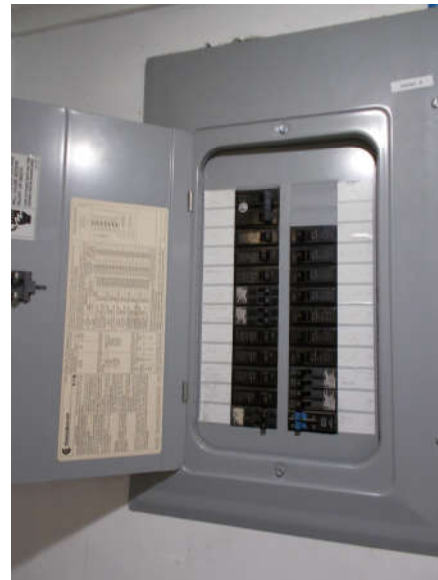
Photo 3 – Panel 2 on first floor

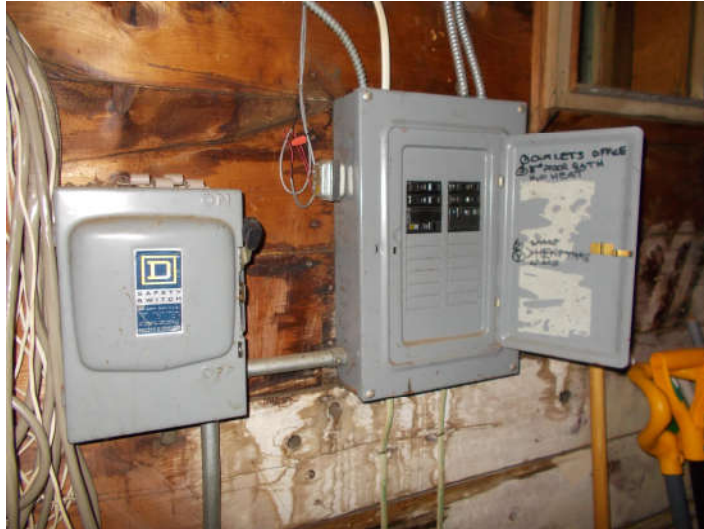
Photo 4 – Attic panel and disconnect switch

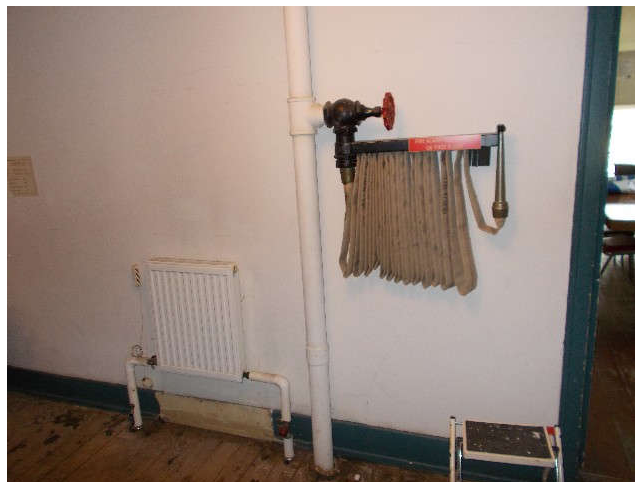
Hose rack located on 2nd floor

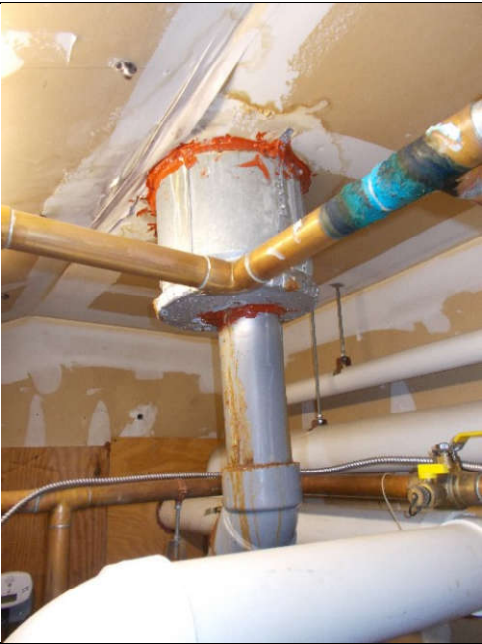
Faulty vent connection above boiler	Evidence of water leakage onto boiler

The CPVC boiler vent pipe connects to a section of larger metal vent pipe, which is not permitted by the manufacturer. The vent should be reconfigured so that the CPVC pipe passes through the roof without interruption. The repair will likely require a roofing contractor to remove the metal pipe and provide flashing around the CPVC vent pipe to create a water-tight penetration.

1. Replace boiler vent piping through roof and seal watertight.
2. Repair corroded copper fittings in boiler room.
3. Service or replace condensate neutralizer at boiler.
4. Verify that condensate pump is rated for boiler temperatures. Relocate pump into drain pan or provide small dedicated pan with water alarm.
5. Replace air handler serving assembly space. Provide new hot water and controls for Demand Control Ventilation, freezestat protection and duct smoke detector.
6. Insulate any exposed hot water valves, controls etc. in attic space.
7. Insulate all hot water piping in basement and provide labels with directional flow arrows.
8. Verify that a water treatment program is in place for the heating system.
9. Clean existing ductwork serving assembly space.
10. Repair or replace broken thermostatic radiator valve.

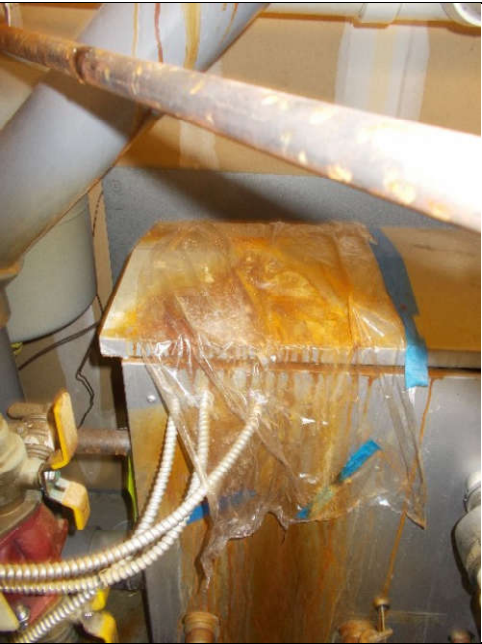
The boiler was manufactured in 2016 and is only 4 years old. However there is significant evidence of water leakage onto the boiler, apparently from the vent penetration through the roof above. This can shorten the service life of the boiler if left unattended, especially if water should come in contact with the boiler’s microprocessor.

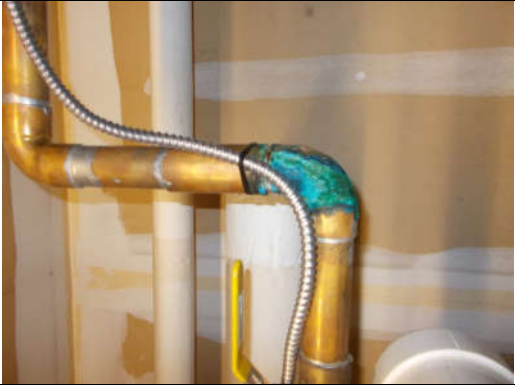
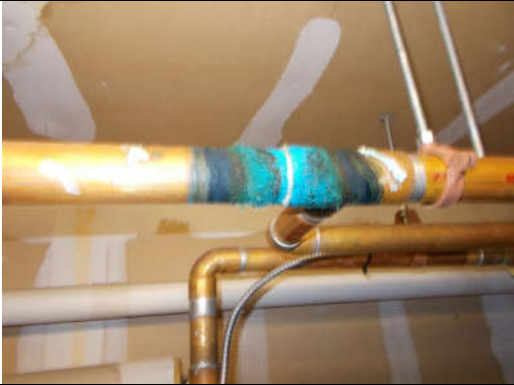
Additional concerns around the boiler include (1) corrosion on at least 2 copper fittings, (2) improper support of a hot water pump, and (3) a condensate neutralizer in need of cleaning or replacement.

Corrosion on copper elbow above boiler	Corrosion on copper tee above boiler

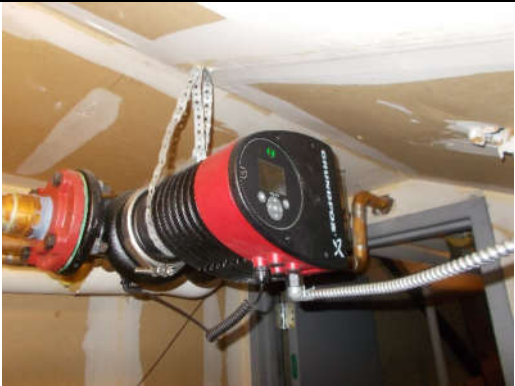
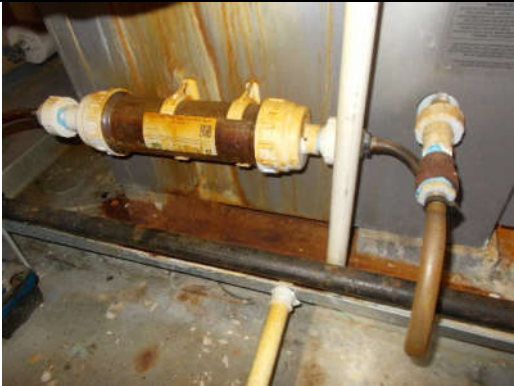
Poor support of Hot water pump	Condensate neutralizer in need of service

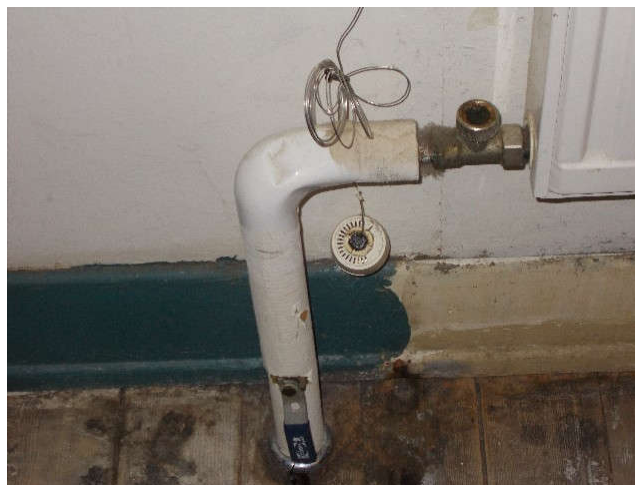
In the 2nd floor corridor, an actuator was found to have been detached from the thermostatic valve at the radiator. This valve should be repaired or replaced.

Broken actuator at thermostatic radiator valve

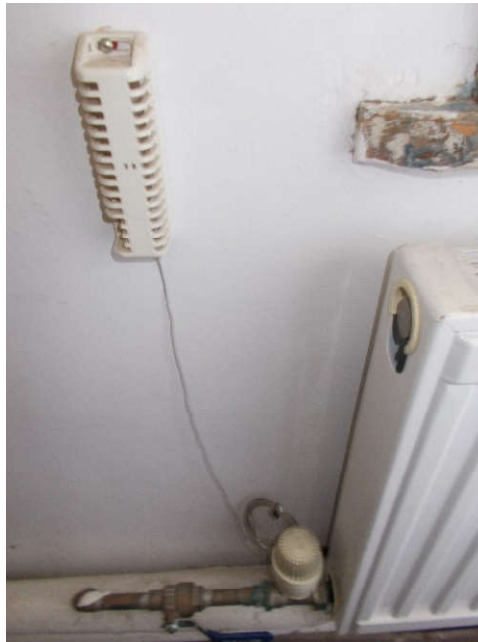
n the 3rd floor, the room on the north side has three hot water radiators. At least one of the radiators has a remote temperature sensor mounted on a cold exterior wall, which can skew its measurements. We recommend changing this valve to the type with an integral sensor to provide more accurate temperature sensing and better comfort.

Remote temperature sensor installed on exterior wall.

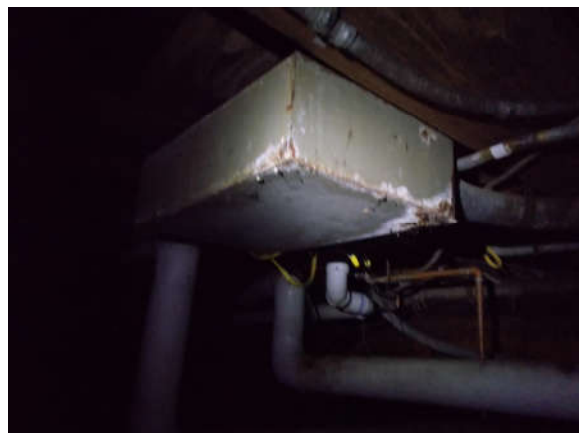
There is a large junction box ceiling mounted in the crawlspace that shows evidence of extensive corrosion which appears to be due to water leakage. The water issue should be mitigated and the junction box replaced.

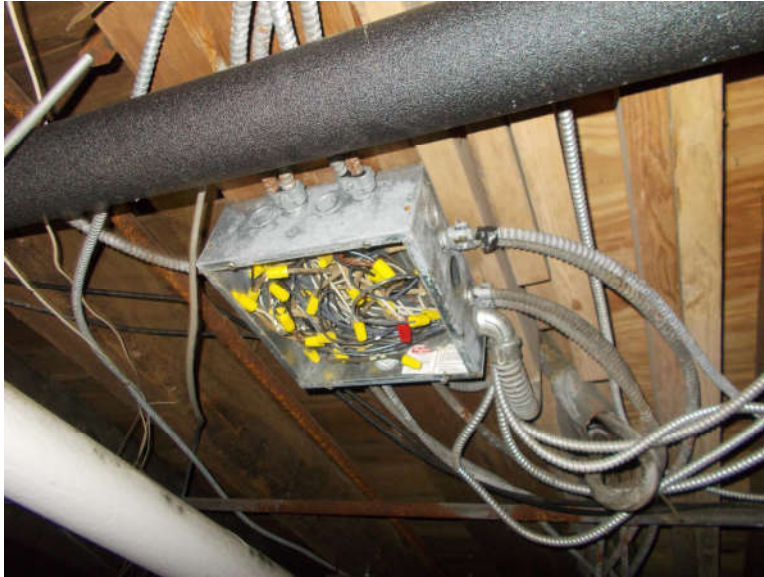
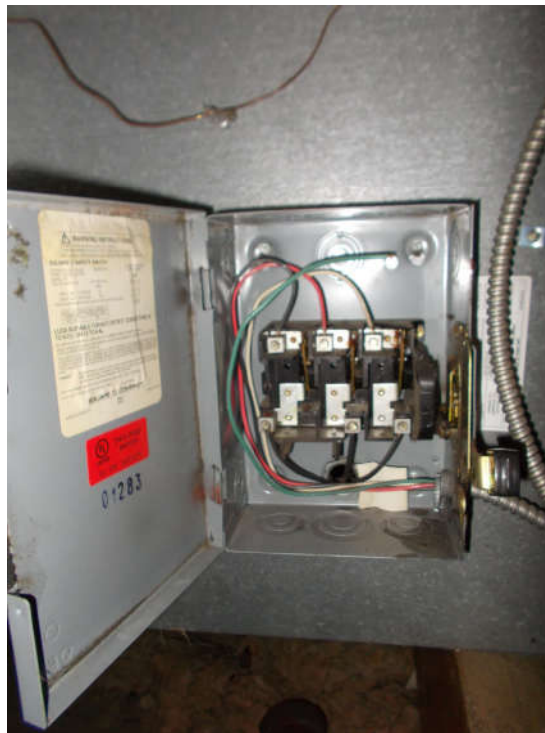
Another large ceiling mounted junction box in the crawlspace is missing its cover plate and exposing live wiring. The cover should be installed over this open junction box.

1. The cloth-insulated conductors for branch wiring in the basement should be replaced with new thermo-plastic insulated conductors in conduit or MC cable. The cloth insulation is delicate and could crumble if disturbed potentially causing a fault resulting in a hazardous condition.
2. Panels do not have current directories. Verify branch circuits and provide current panel directories for all electrical panels.
3. Provide panel tags for panel in crawlspace and attic.
4. There appears to be corrosion on the contacts of the disconnect switch serving the air handling unit and should be verified. If so, this switch should be replaced and cause of corrosion mitigated.
5. Provide covers for all open junction boxes in basement and attic.
