## Pedestrian Circulation

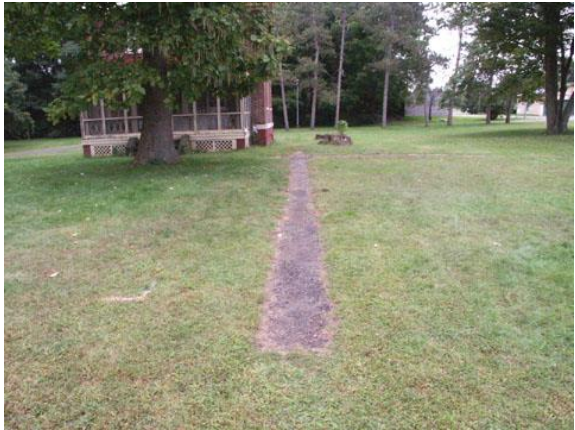
Asphalt walks are located near the Ministry Shop and along the east side of Meeting House Road, between the Meeting House and Ann Lee Pond. All of these walks are in poor condition with broken and uneven surfaces and with edges covered with weeds and grass...

Asphalt walk leading to the Ministry Shop.

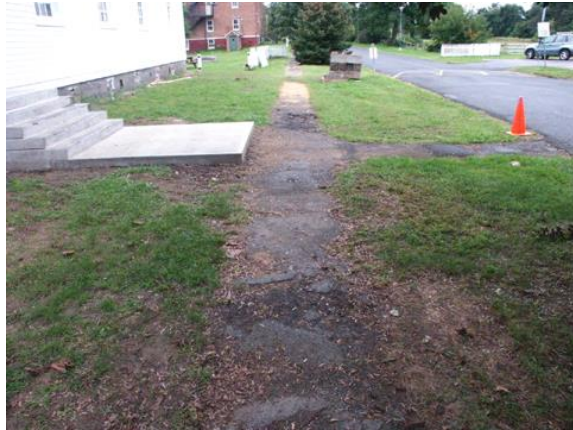
Asphalt walks at the Meeting House.

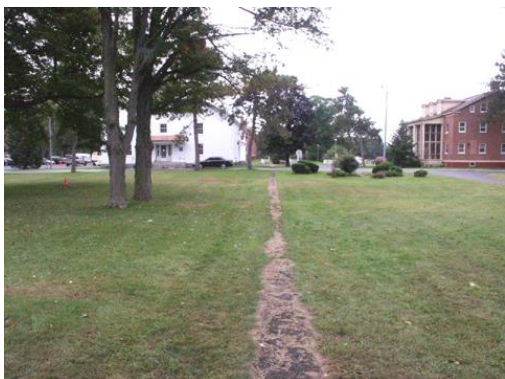
One crushed stone walk exists between Meeting House Road and the Ministry Shop. This walk is in poor condition owing to its uneven surface and weed infested edges.

This crushed stone walk between the Meeting House and the Ministry Shop appears to be in alignment with the historic quadrangle stone paths.
